# Shoreline Situation Report STAFFORD COUNTY, VIRGINIA

Special Report in Applied Marine Science and Ocean Engineering Number 79  
Coastal Zone Information Center  
Chesapeake Research Consortium Report Number 13  
2/1/48 1978

VIRGINIA INSTITUTE OF MARINE SCIENCE  
Gloucester Point, Virginia 23062

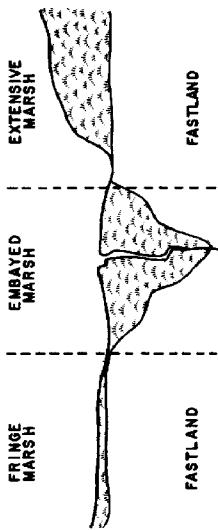
Figure 2

The physiographic character of the marshes has also been separated into three types (see Figure 2). Fringe marsh is that which is less than 400 feet in width and which runs in a band parallel to the shore. Extensive marsh is that which has extensive acreage projecting into an estuary or river. An embayed marsh is a marsh which occupies a reentrant or drowned creek valley. The purpose in delineating these marsh types is that the effectiveness of the various functions of the marsh will, in part, be determined by type of exposure to the estuarine system. A fringe marsh may, for example, have maximum value as a buffer to wave erosion of the fastland.

A generalized illustration of the three different marsh types.

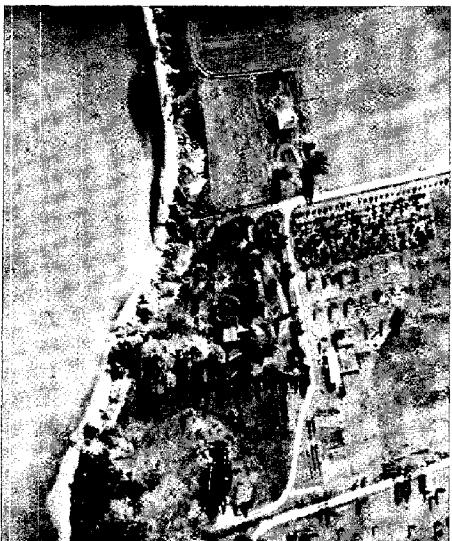
Figure 3

3. Aerial view of Youbedam Landing at the mouth of Aquia Creek on the Potomac River. The blunt end of the peninsula is experiencing severe erosion, as evidenced by the separation of the groins from the mainland. The large, partially filled groinfield on the Potomac River is trapping some of the eroded material.

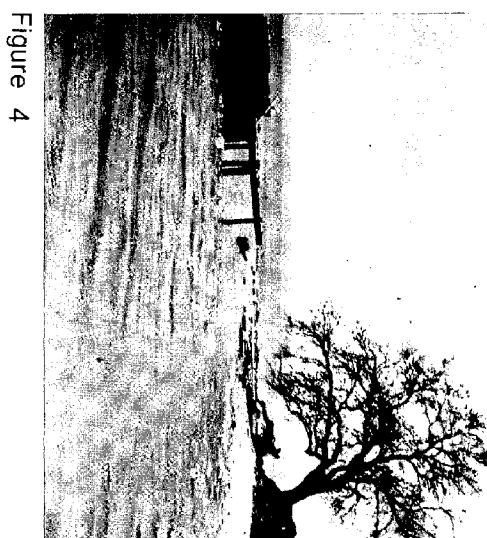
Figure 4

5. An area of very severe erosion just north of Marlboro Point on the Potomac River. The high bluff consists of unconsolidated sediments that are easily eroded by waves. Most attempts at shore protection have met with little or no success as they have not been of sufficient scope to stem the problem.

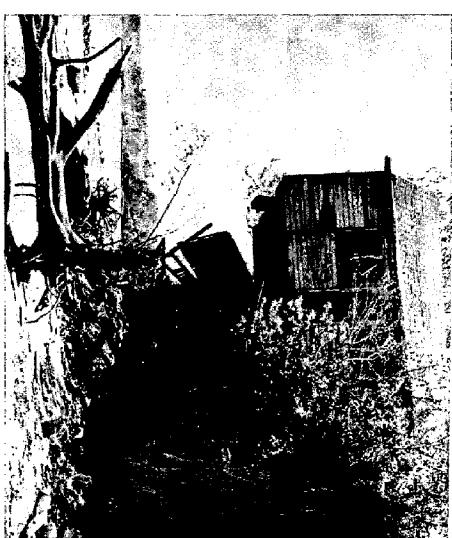
Figure 6

6. A ground view near Marlboro Point, south of the area shown in the preceding photograph. The great erosion has removed much of the bank, significantly undercutting the house.

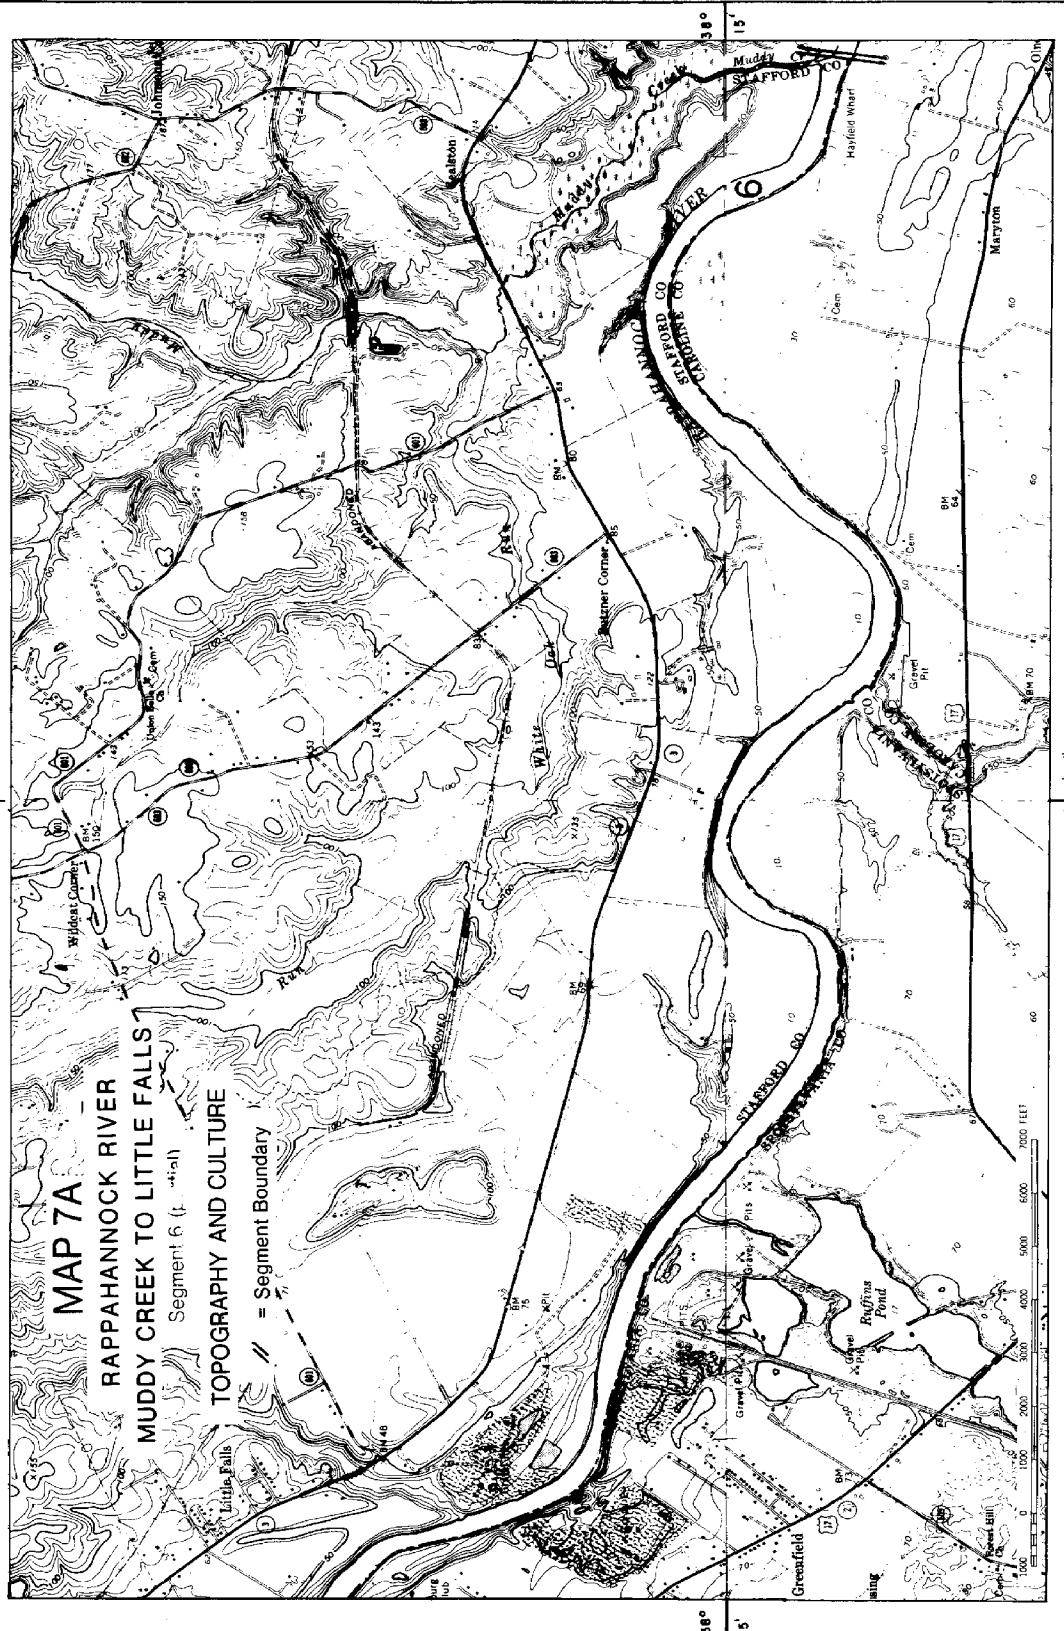
**MAP 7A**  
**RAPPAHANNOCK RIVER**  
**MUDY CREEK TO LITTLE FALLS**

TOPOGRAPHY AND CULTURE  
Segment F (4 miles)
